WHY AT THE BEGINNING OF THE 21ST CENTURY IS BASEMENT WATER - PROOFING ACCEPTED AS A HIGH RISK OPERATION?

Case History :- Anthony Nolan Nolan Bone Marrow Appeal Laboratories,
Royal Free NHS Trust, Hampstead, by Trace Basement Systems

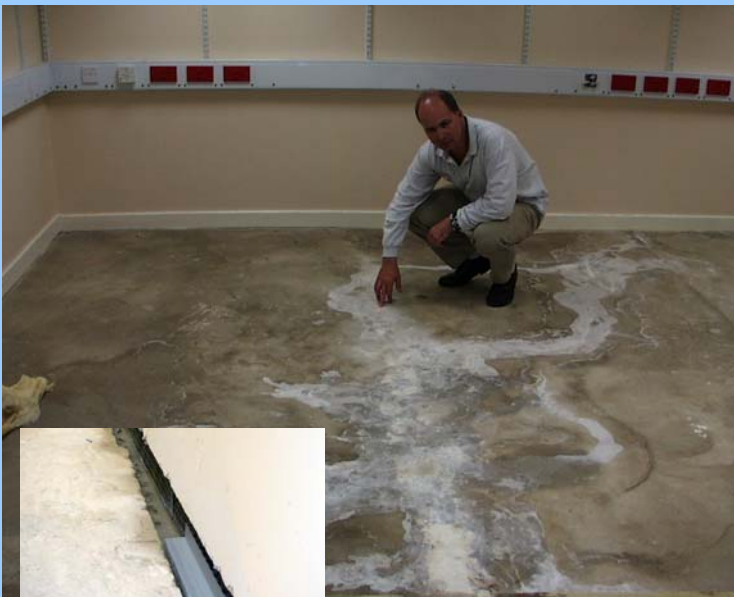
Shortly after opening the new wing with a basement of some 30m by 15m the basement flooded.

At the time of construction, an adhesive membrane was applied to the ground retaining walls on the negative side within the cavity, continued across the floor slab below a screed. Ground water pressure subsequently forced the membrane to push off or break seals at overlaps, resulting in escape of water at the vulnerable wall and floor joints, with standing water upon the floors. Repairs were initially undertaken by applying cementitious tanking to the existing walls and floors in an attempt to 'hold back the dam', but heave occurred, causing the second tanking medium to crack and allow more water to escape.

WaterGuard™ drainage channels and two Supersumps™ with battery back up were installed, controlling and removing the offending water, with Cavity Drainage membrane laid on the slab, covered in a floating timber floor of Waterproof chipboard. The WaterGuard™ channel relieved the pressure, allowing the waterproofing on the walls to remain largely undisturbed. As a precaution a skirt of cavity drain membrane was formed allowing future extension of the system in case water later entered at high level through the walls.

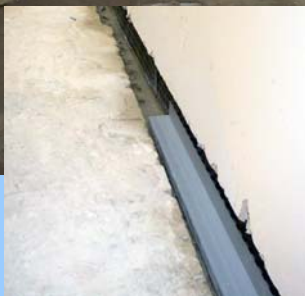
Ray Foulkes of Basement Systems UK investigates the water ingress through the failed waterproof screed and (inset) the Waterguard channel™ prior to concreting in at the wall floor joint.
